# IAQ Summary

7-18-24 through 8-15-24

***We deployed 10 IAQ sensors on floors 29, 30, and 31***

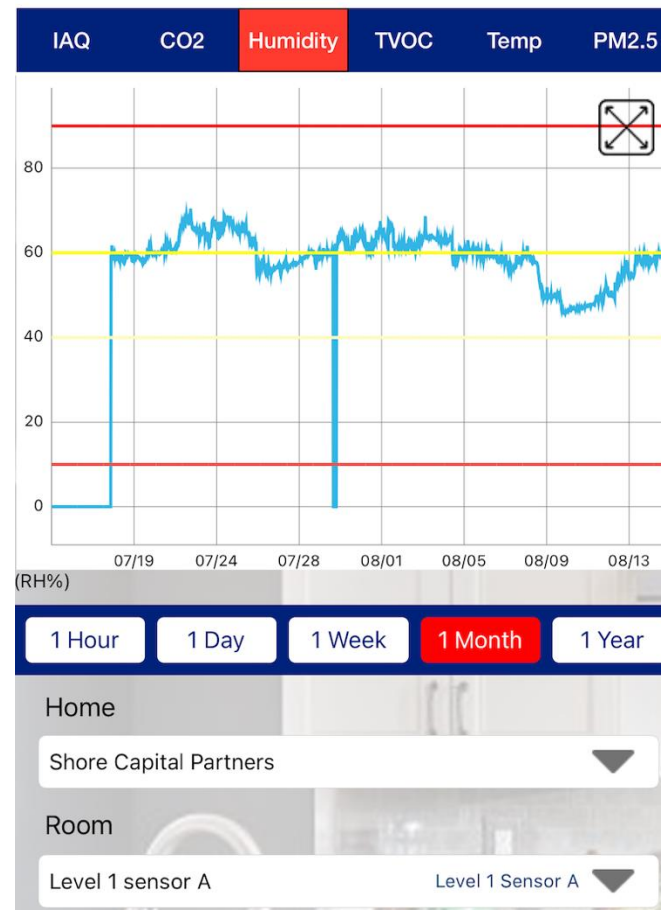
# Floor 29 Results – Sensor A: Relative Humidity

- Relative humidity ranged from 50%, which is good, to ~ 70% in late July, which is uncomfortable. RH levels above 60% are not recommended.
- Loss of Wi-Fi signal on ~ 7-30-24.
- The blue line is the actual sensor data.

- I recommend using enhanced dehumidification strategies (reheat, slowing down the process air flow, colder coils, energy recovery, or dedicated DOAS/dehumidification systems) when the outside air dew point is above 60°F to limit over-wetting the conditioned space from the ventilation air.

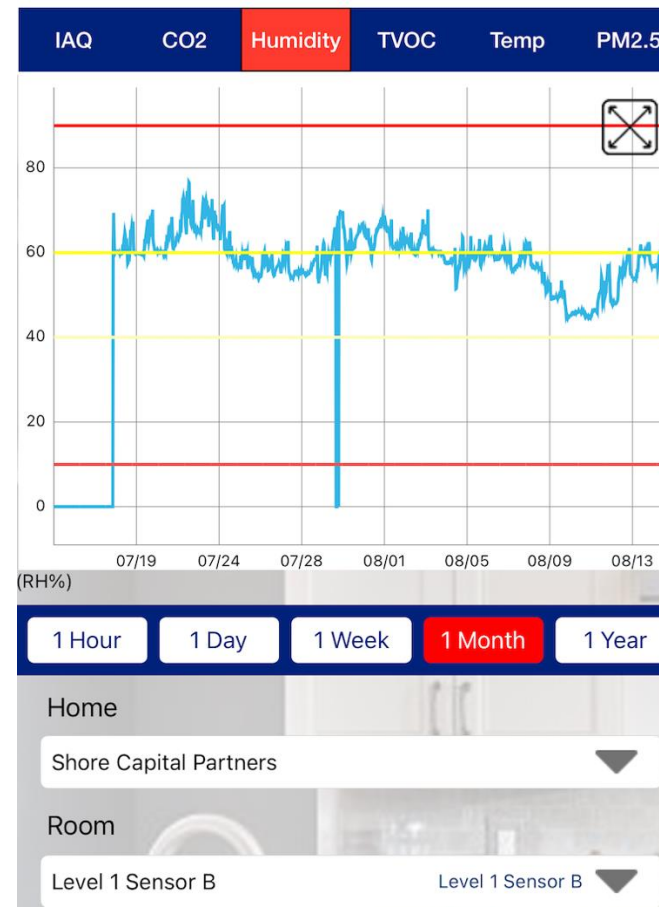
# Floor 29 Results – Sensor B: Relative Humidity

- Relative humidity ranged from 45%, which is good, to ~ 75% in late July, which is uncomfortable. RH levels above 60% are not recommended.
- Loss of Wi-Fi signal on ~ 7-30-24.

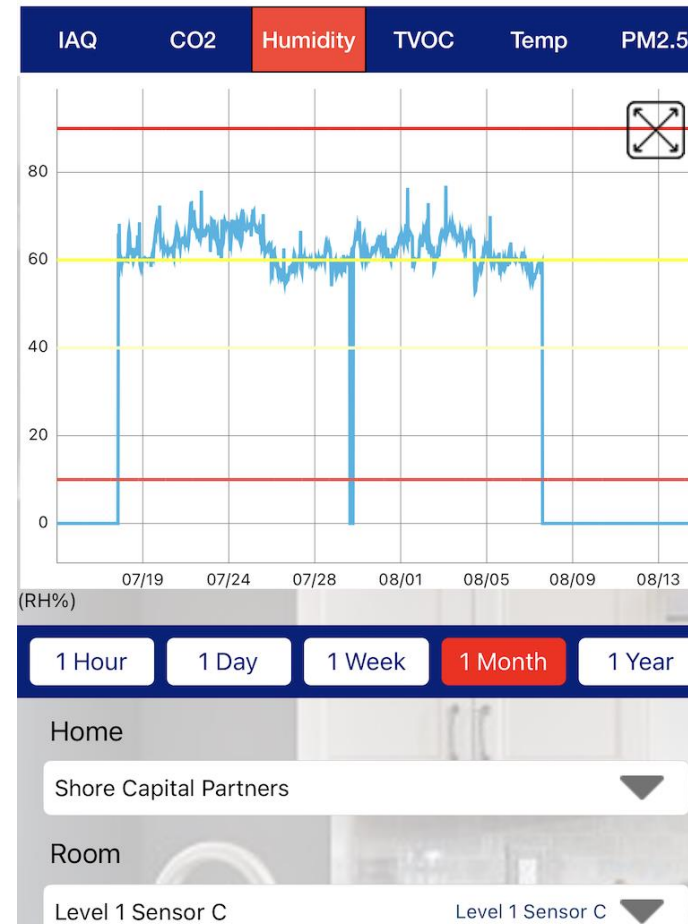
# Floor 29 Results – Sensor C: Relative Humidity

- Relative humidity ranged from 55%, which is barely acceptable, to ~ 75% multiple times, which is uncomfortable. RH levels above 60% are not recommended.
- Loss of Wi-Fi signal on ~ 7-30-24.
- Sensor unplugged on ~ 8-8-24.

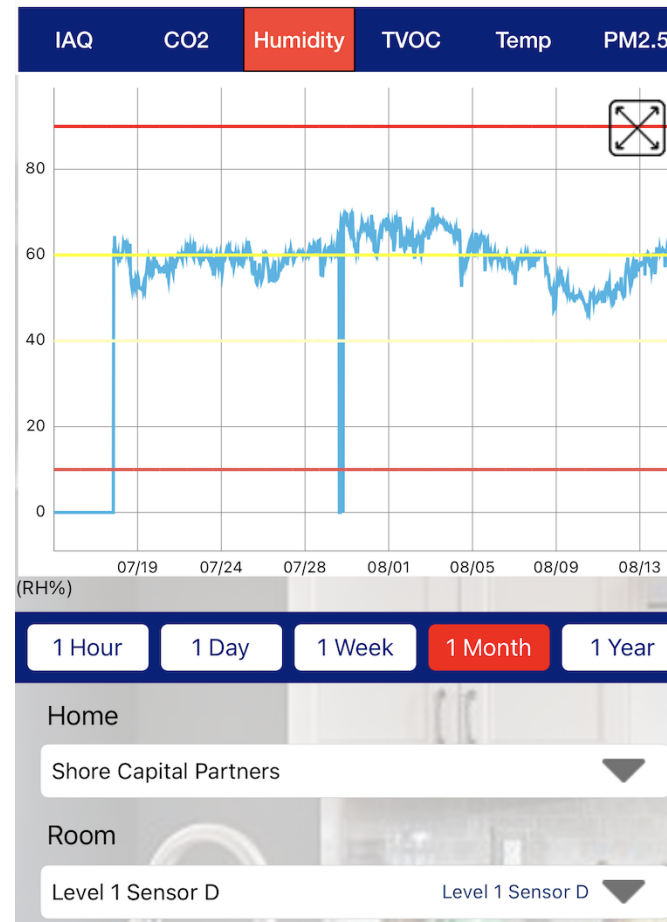
# Floor 29 Results – Sensor D: Relative Humidity

- Relative humidity ranged from 45% to ~ 70% multiple times, which is uncomfortable. RH levels above 60% are not recommended.
- This area outperformed the other sensor areas on Floor 29, possibly due to low occupant density or proximity to HVAC supply vents.
- Loss of Wi-Fi signal on ~ 7-30-24.

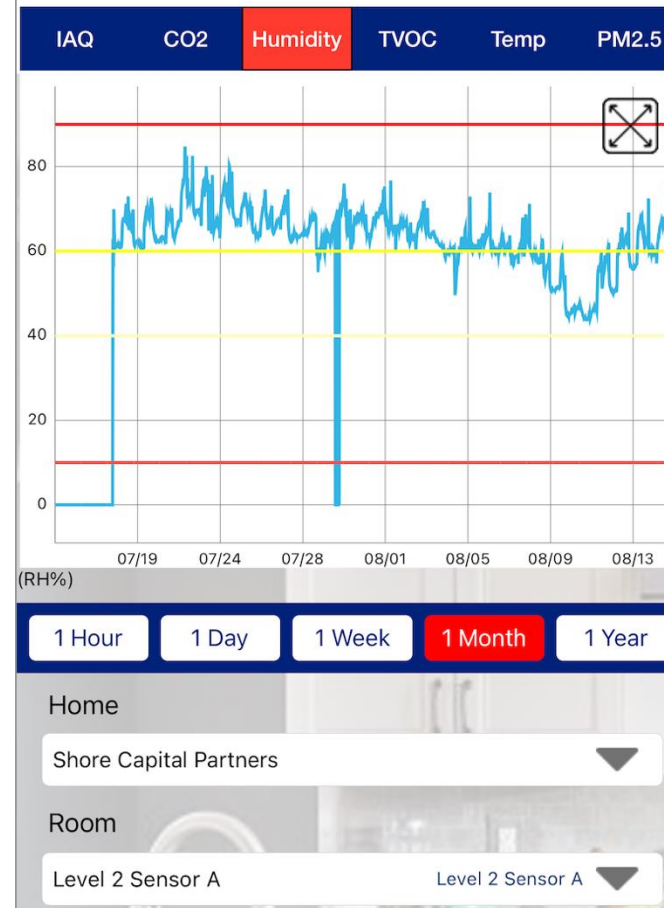
# Floor 30 Results – Sensor A: Relative Humidity

- Relative humidity ranged from 45%, which is barely acceptable, to ~ 82% multiple times, which is not acceptable. RH levels above 60% are not recommended.
- Loss of Wi-Fi signal on ~ 7-30-24.

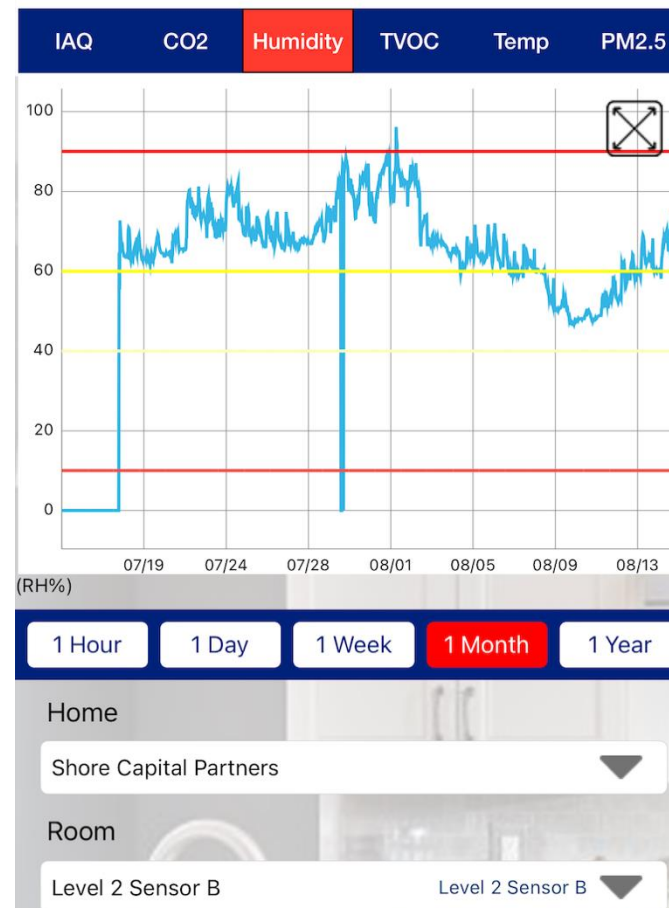
# Floor 30 Results – Sensor B: Relative Humidity

- Relative humidity ranged from 50% to ~ 90% multiple times, which is not acceptable. RH levels above 60% are not recommended.
- Loss of Wi-Fi signal on ~ 7-30-24.

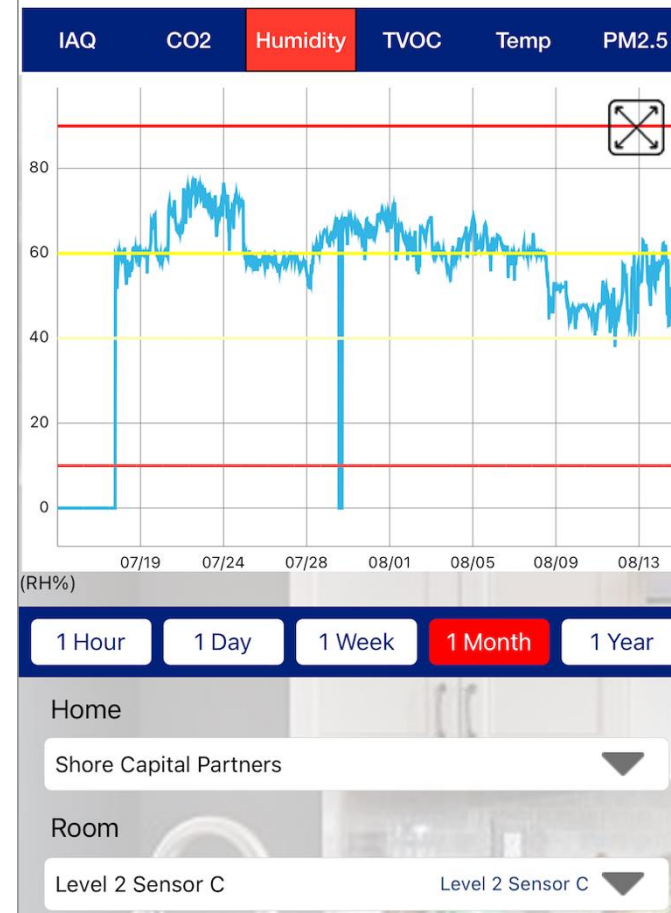
# Floor 30 Results – Sensor C: Relative Humidity

- Relative humidity ranged from 40%, which is good, to ~75%, which is not acceptable. RH levels above 60% are not recommended.
- Loss of Wi-Fi signal on ~ 7-30-24.

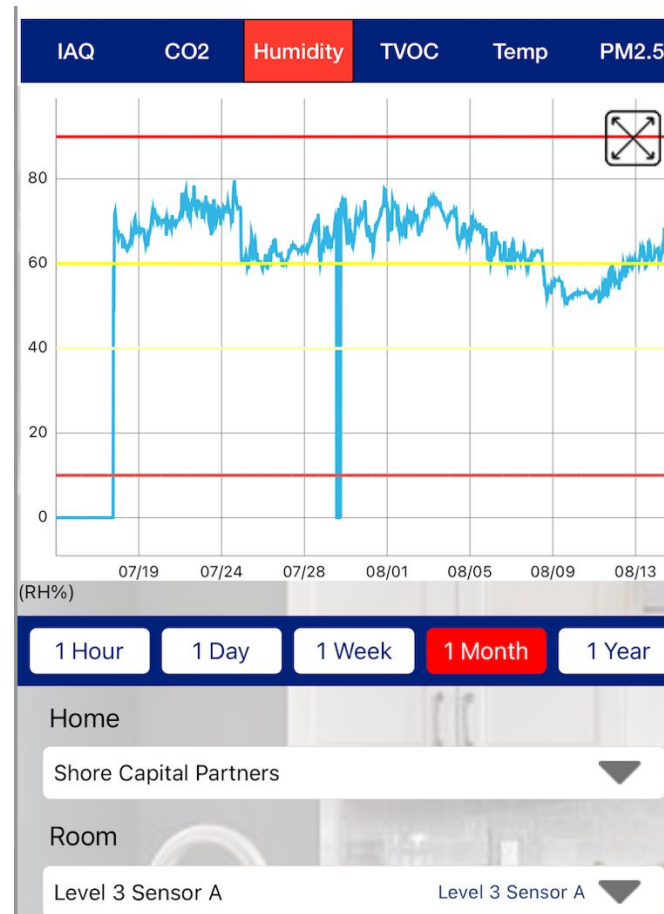
# Floor 31 Results – Sensor A: Relative Humidity

- Relative humidity ranged from 50% to ~ 80% multiple times, which is not acceptable. RH levels above 60% are not recommended.
- Loss of Wi-Fi signal on ~ 7-30-24.

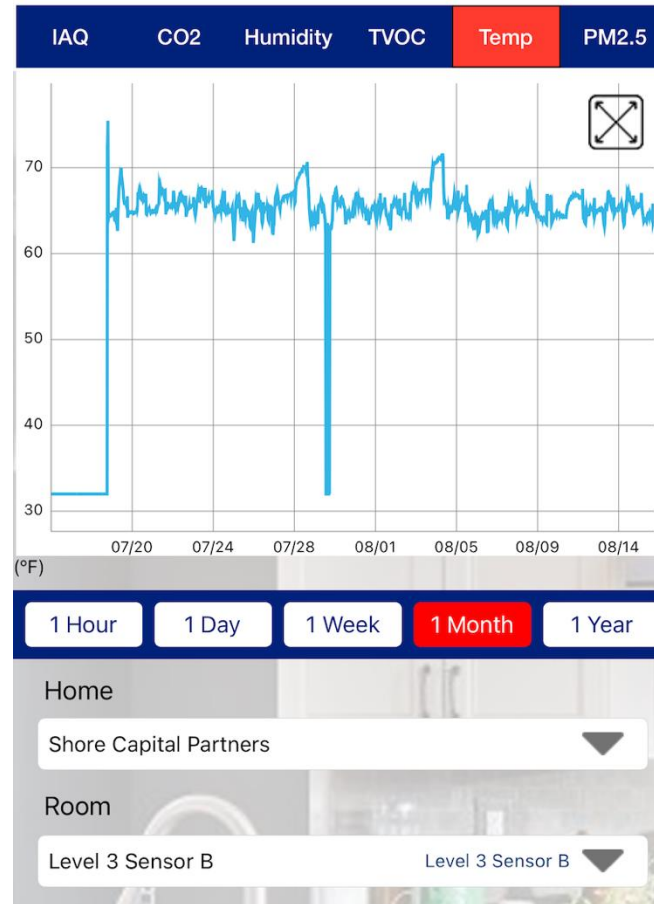
# Floor 31 Results – Sensor B: Temperature

- Temperature ranged from ~ 63°F to ~ 66°F during the test, which is colder than the other sensors.
- These cold readings may be caused by the sensor being blown on by a HVAC system supply vent or by the thermostat setpoint being too low.
- The temperature stayed high on 7-28 and 8-4 indicating a higher thermostat setpoint for the weekend.
- Loss of Wi-Fi signal on ~ 7-30-24.

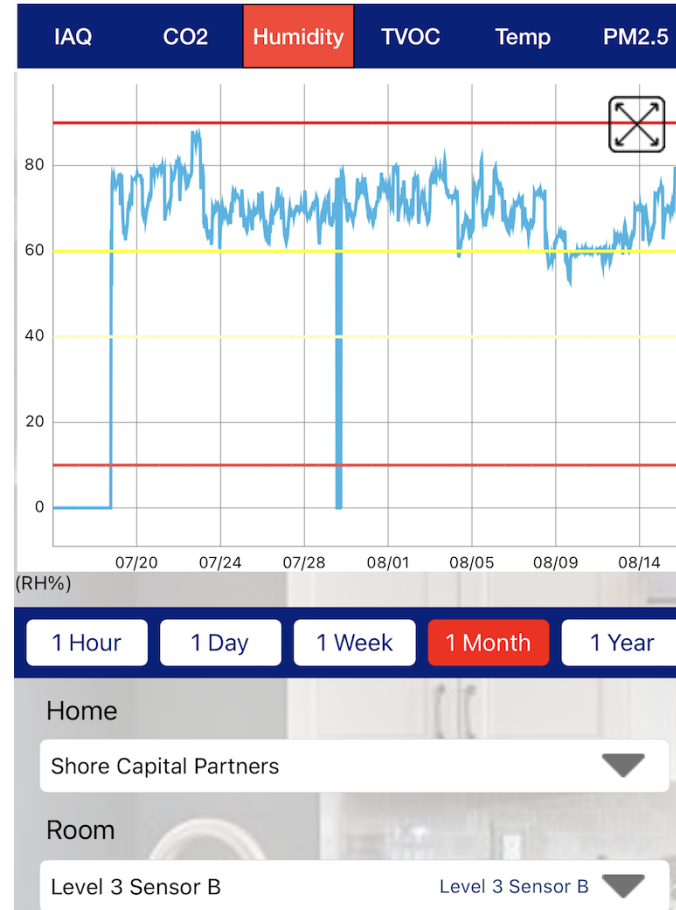
# Floor 31 Results – Sensor B: Relative Humidity

- Relative humidity ranged from 50% to ~ 90%, which is not acceptable. RH levels above 60% are not recommended.
- These high RH readings coupled with the lower-than-average temperature readings from this sensor could be due to the sensor being in the airstream from an HVAC vent or a low thermostat setpoint.
- Loss of Wi-Fi signal on ~ 7-30-24.

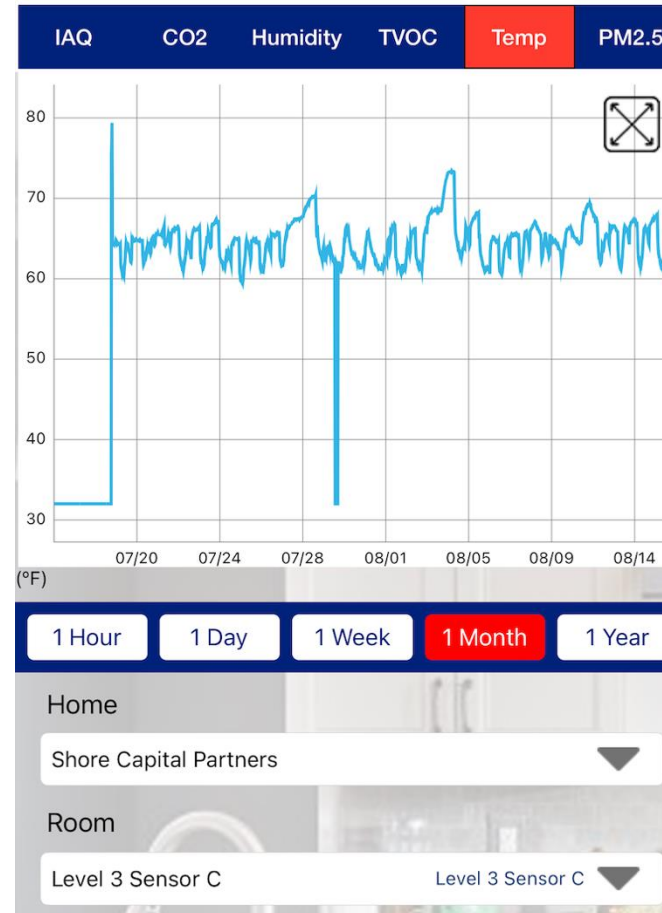
# Floor 31 Results – Sensor C: Temperature

- Temperature ranged from ~ 60°F to ~ 66°F during the test. This space is being over cooled.
- These cold readings may be caused by the sensor being blown on by a HVAC system supply vent or by the thermostat placement or malfunction.
- The temperature stayed higher on 7-28 and 8-4 indicating a higher thermostat setpoint for the weekend.
- Loss of Wi-Fi signal on ~ 7-30-24.

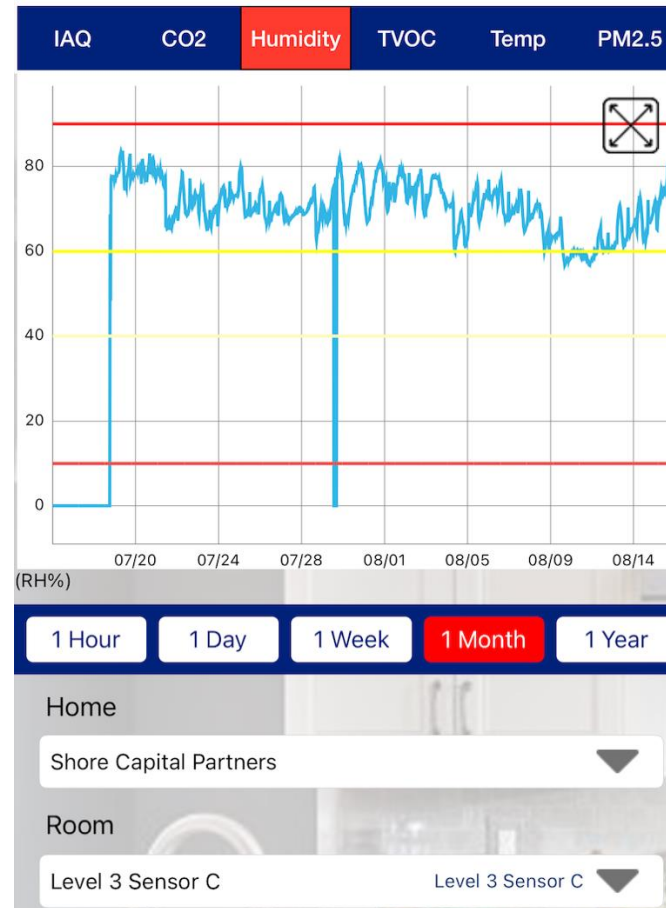
# Floor 31 Results – Sensor C: Relative Humidity

- Relative humidity ranged from 50% to ~ 80%, which is not acceptable. RH levels above 60% are not recommended.
- These high RH readings coupled with the lower-than-average temperature readings from this sensor could be due to the sensor being in the airstream from an HVAC vent.
- Loss of Wi-Fi signal on ~ 7-30-24.

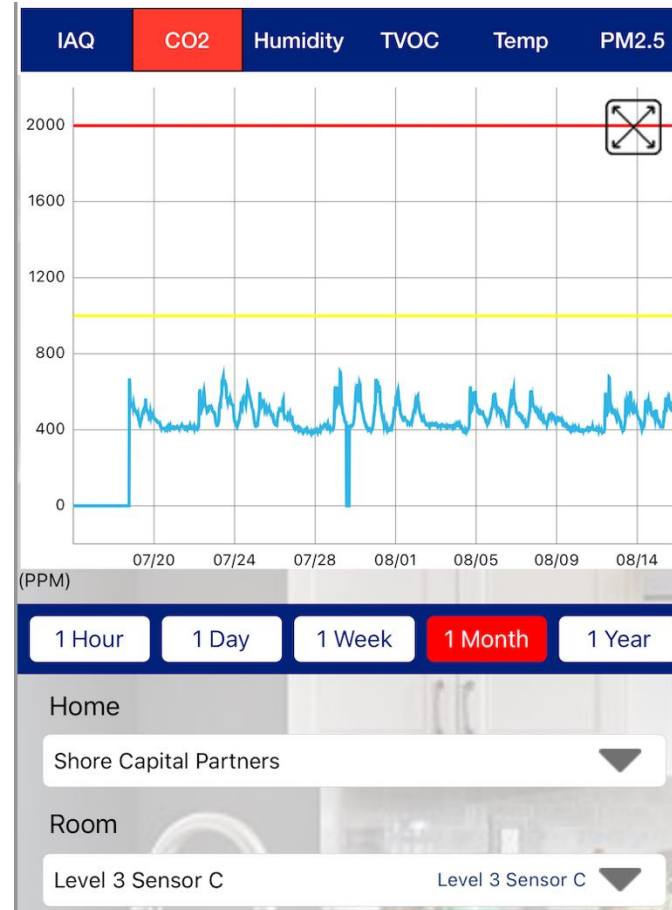
# Floor 31 Results – Sensor C: Carbon Dioxide

- Carbon dioxide levels ranged from ~ 400 ppm, which is excellent and essentially the outdoors concentration, to ~ 700 ppm, which is also excellent.
- Note how you can see the daily workday peaks due to occupancy and the flattening out to 400 ppm on the weekends when there is little to no occupancy.
- Loss of Wi-Fi signal on ~ 7-30-24.

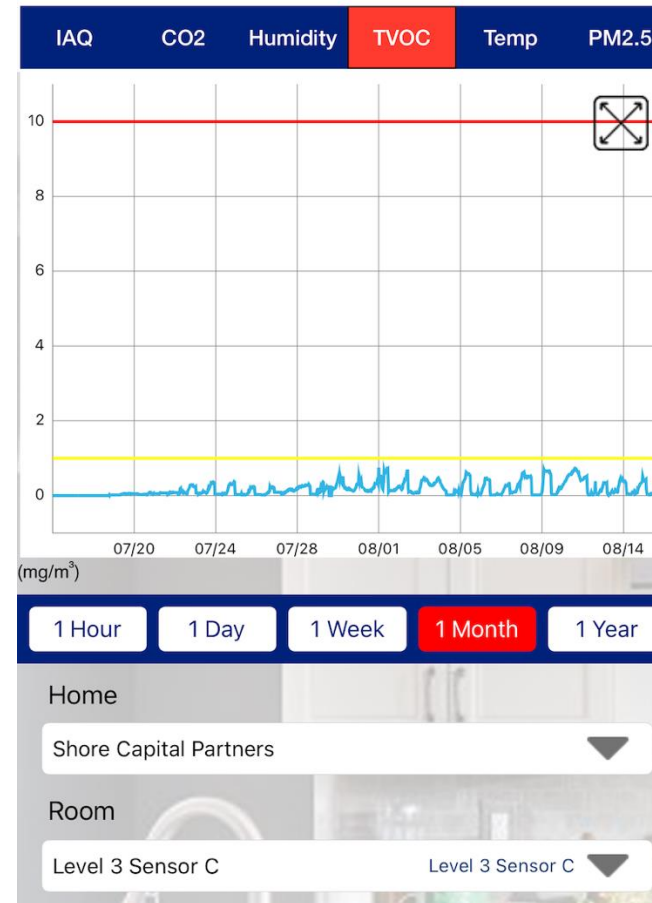
# Floor 31 Results – Sensor C: TVOCs

- Total volatile organic compounds ranged from ~ 0  $\mu\text{g}/\text{m}^3$  to ~ 1  $\mu\text{g}/\text{m}^3$  during the test, which is good.
